**EXPERIMENTAL STUDY OF THE EFFECT OF CRACKS ON ALUMINUM 5083-H111 AND THE DIRECTION OF CRACK GROWTH, NUMERICALLY AND EXPERIMENTALLY.**

**Ali Jasim Mohammed<sup>1</sup>, Prof. Dr. Abdullah Dhayea<sup>2</sup>**

**Abstract:**

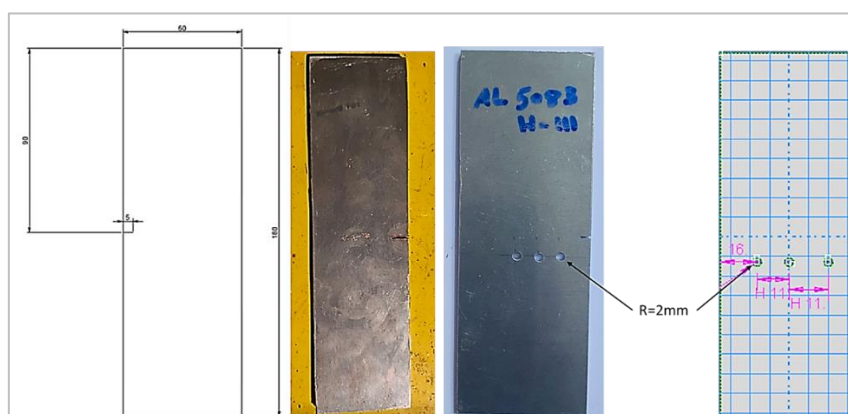
**Figure (3-1) Dimensions of the designed test specimens**

Test samples were designed in the laboratory with dimensions of 60\*180\*3 mm and a crack in one of the edges in the middle. The length of the crack was 5 mm. I designed it in AutoCAD 2022. The samples were cut after drawing and transferred to the cutting machine. A model containing three holes was used. The distances between the center of the circle and the other circle were (11 and 15) mm. Also, its distance from the original crack was in horizontal and vertical directions, as shown in the figure (3-1).

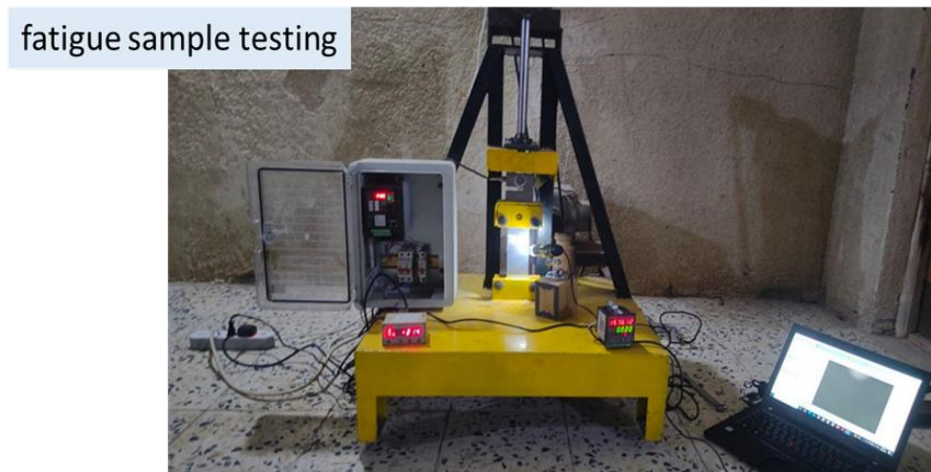
**Figure (4-1) fatigue test machine**

The samples were tested in a uniaxial fatigue machine at a constant amplitude with a dynamic load of 6 kN and a number of cycles at 24 Hz, as shown in Figure (4-1). This shows the

fatigue test to which the test samples were subjected. A number of samples were tested, and the changes occurring in each sample were monitored. After that, an average was taken in our research.
